# Manhole Inspection Summary

Manhole # S33C\_\_018MH

Insp Date: **8/1/08 9:25 AM**

**Location** Address: **128 w pleasant st**

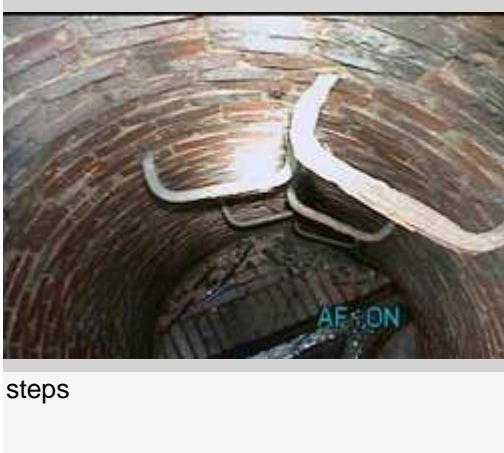
Defect 3

Count: **5** Missing: **0** ☒ **Corroded**

steps

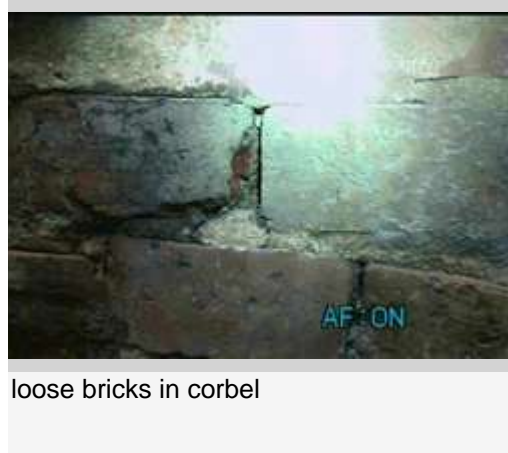
Defect 2

Condition: ☐ Sound ☐ Cracked ☐ Root Intrusion ☒ **Loose Brick** ☐ Deteriorated

loose bricks in corbel

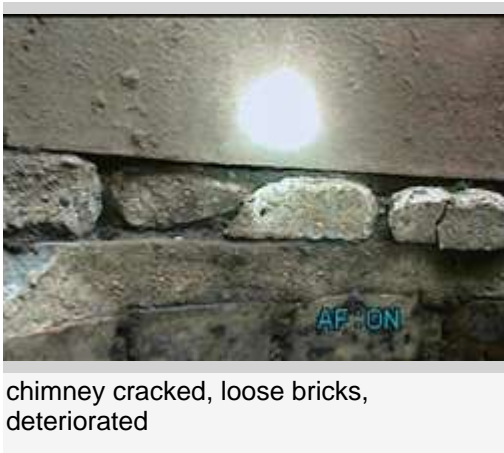
Defect 1

Condition: ☐ Sound ☒ **Cracked** ☐ Root Intrusion ☒ **Loose Brick** ☒ **Deteriorated**

chimney cracked, loose bricks,  
deteriorated

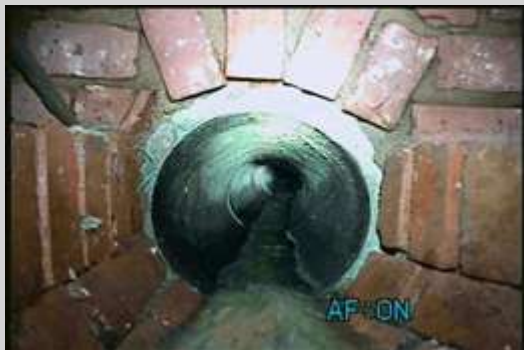
12 O'Clock Outflow

8 in. Circular Gravity Sewer  
Pipe Out @ 12 O'Clock

Pipe Material: **Clay** ☐ Pipe Lined

Invert Depth: **10.44** (ft.) Flow Characteristics: **Slow**

Infiltration: **None** Pipe Seal Cond: **Unknown**

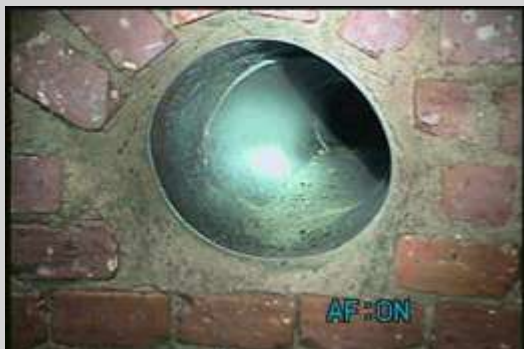
3 O'Clock Inflow

8 in. Circular Gravity Sewer  
Pipe In @ 3 O'Clock

Pipe Material: **Clay** ☐ Pipe Lined

Invert Depth: **7.00** (ft.) Flow Characteristics: **Slow**

Infiltration: **None** Pipe Seal Cond: **Unknown**

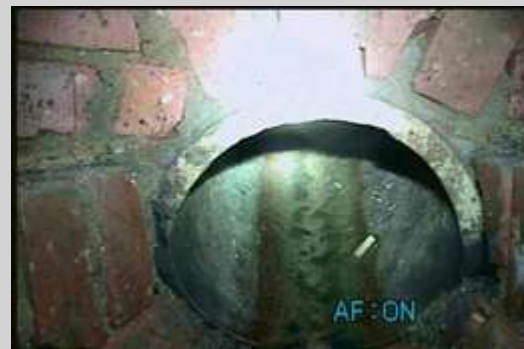
Drop In @ 3 O'Clock

Drop: **Outside Direct**

Inv Depth: **10.30** (ft.)

Drop Condition: **Open**

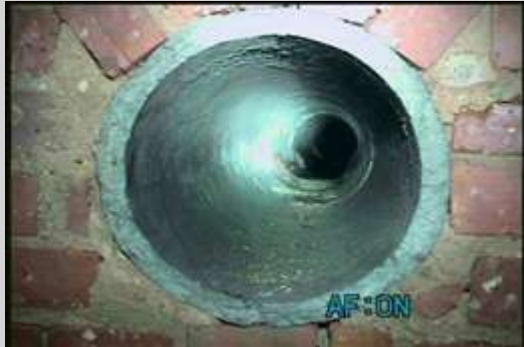
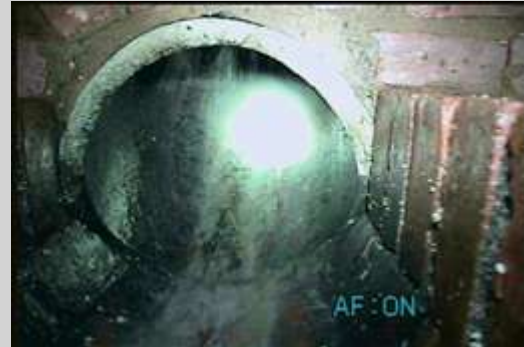
6 O'Clock Inflow

Pipe In @ 6 OClock

Drop In @ 6 OClock

Pipe Material: **Clay** ☐ Pipe Lined

Invert Depth: **7.70** (ft.) Flow Characteristics: **Slow**

Drop: **Outside Direct**

Drop Condition: **Open**
